Model: LC-12.56
Chlor-Scale Ton Container Scales
Chem-Scales over 1,000 lbs.

**PROPER LOAD CELL
PISTON GAP**

Drawing Number
29929

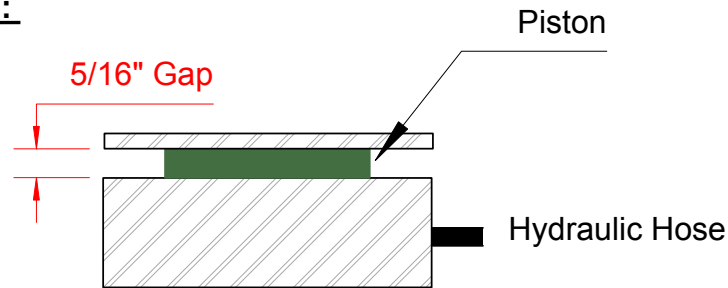
**CORRECT
5/16" Piston Gap**

Inaccurate readings may be caused by a loss of hydraulic oil in the Load Cell. Top off Load Cell by adding oil at filler plug.

Refilling system should be done with SAE-5 or -10 Weight, Non-Detergent Machine Oil. Automatic Transmission can also be used.

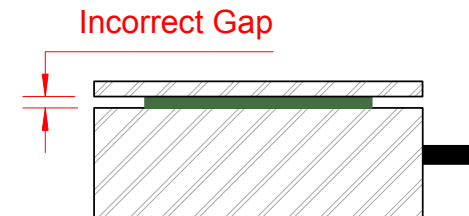
**INCORRECT
Piston Gap**

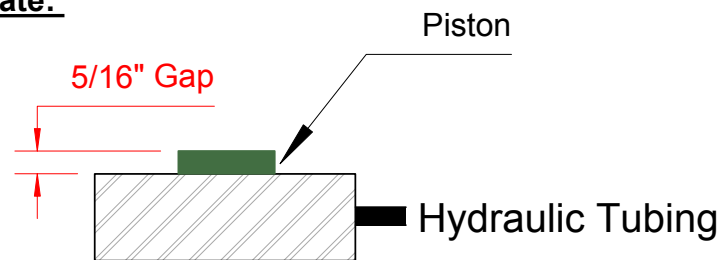
**CORRECT
5/16" Piston Gap**

**INCORRECT
Piston Gap**
